# Sidewall Cord Impact Break (Bubble)

# NEXEN TYRE

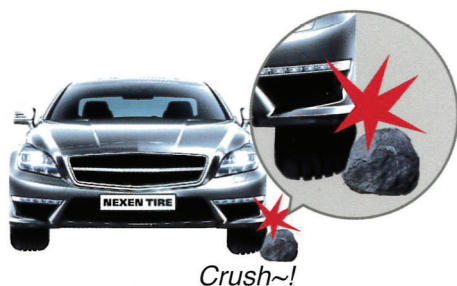
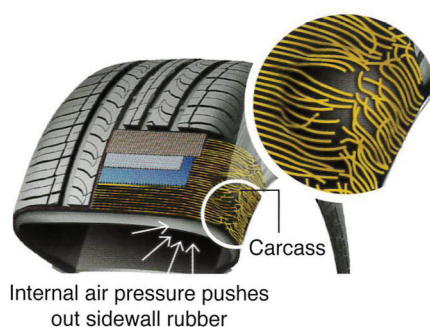
The carcass contains textile cord topping layers between steel belt and inner liner. If the textile cords of carcass are damaged due to sudden impact with a road hazard or a pothole, the sidewall of tire may arise like bump. This is why the internal air pressure pushes the surface through the gap in the cord. This is called Cord Impact Break(Bubble).

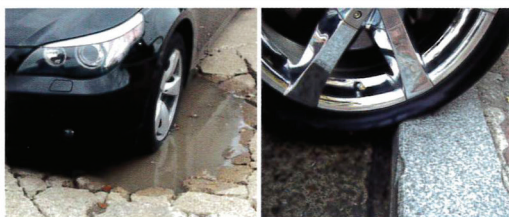
Impact damage such as curb / pothole

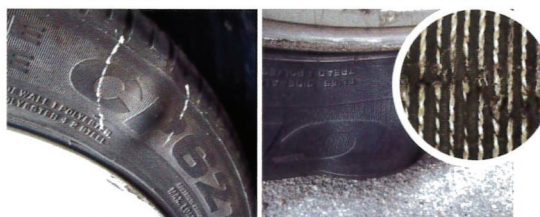
Localized protrusion in the sidewall
