# Sidewall Cord Impact Break (Bubble)

# NEXEN TYRE

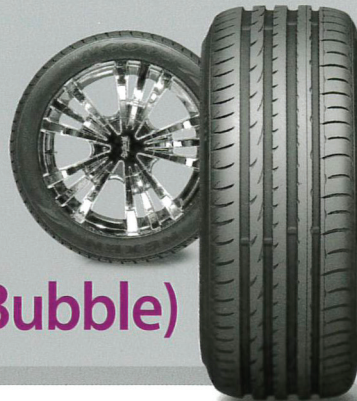
The carcass contains textile cord topping layers between steel belt and inner liner. If the textile cords of carcass are damaged due to sudden impact with a road hazard or a pothole, the sidewall of tire may arise like bump. This is why the internal air pressure pushes the surface through the gap in the cord. This is called Cord Impact Break(Bubble).

Avoid tread surface cuts and pothole impact if possible.

Drive on harsh bumpy road at low speed.

Maintain proper tire inflation pressure.

Check the tire for damage frequently.

Avoid contact with curbs.
